A Case Study on Renewal Strategies Concerning Lost Technologies in Construction of Rubber Gates

Tomoji Takatsu^{1,a}, Kohei Nagano^{1,b}, Shuji Takasu^{1,c}

¹ Japan Dam Engineering Center, 2-9-7 Ikenohata, Taito-ku, Tokyo, JAPAN

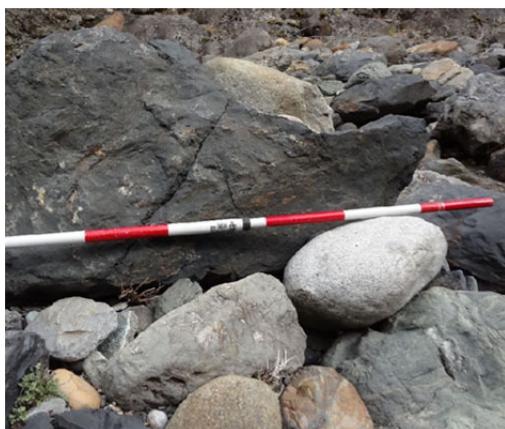
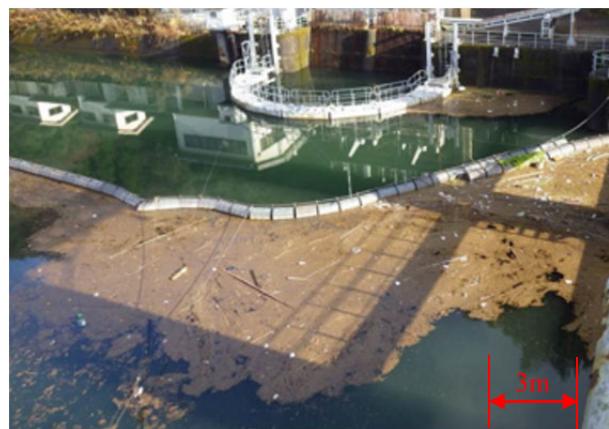
The sample photos in Figure 2 show rolling stones (on the left) and flood/drift woods (on the right). The diameters of rolling stones with sharp edges are over 20 cm. The length of flood/drift woods is over 5 m. So they have enough potential to damage rubber gates.

Samples of rolling stones

Samples of flood/drift woods

Figure 2. Samples of flood/drift woods on rivers

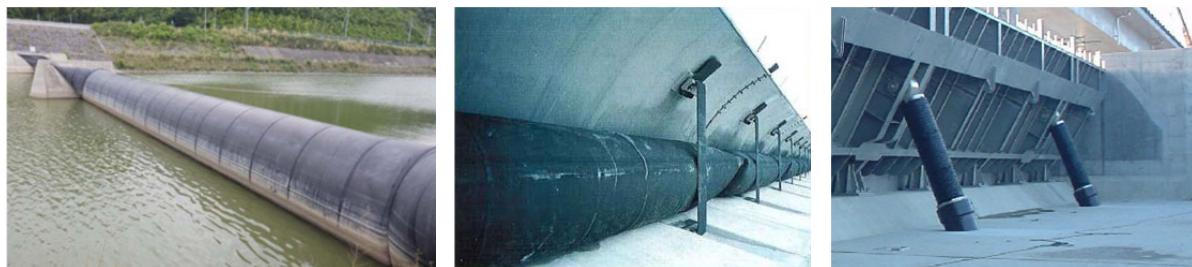
Rubber Gate

Steel Flap Gate
with Rubber Bladders

Steel Flap Gate
with Hydraulic Cylinders

Figure 9. Samples of rubber gate and steel flap gate with rubber bladders and hydraulic cylinders

When the inspections in the previous section give results which are neither sound nor follow-up observations, those gates must be repaired or renewed. Firstly, let us consider the case of replacing. The authors assumed that protective layer rubber bag with the ceramics chips cannot be manufactured due to their peculiarity. In fact, the author recognizes the case that the manufacturer withdraws. Then, we must select an alternative technology from Table 1. Options 3 and 5 in Table 1 are not effective enough. Moreover, the authors assumed that Options 2 and 4 cannot be sufficiently procured. Only by making these assumptions were the authors able to negate all five options. Consequently, none of the five options has both abrasion resistance and availability. At this point, repairs are not possible due to unavailability of ceramics. Therefore, this is no longer repair, but renewal with a different type of gate. The candidates for gate types are steel flap gate with single/double rubber bladders and steel flap gate with hydraulic cylinders.

The authors then compared these three candidates. The allowed water level in target river caused the constraint of gate height to be 4 m. With this constraint, the height of riverbed becomes higher than the present height when selecting steel flap gate with single/double rubber bladders. This is the reason why steel flap gates with height more than 2.5 m for single rubber bladder, or 3 m for double ones, cannot be installed. Table 4 shows their comparison, while Figure 9 shows sample pictures of them. Since a lift-up is needed in case of a steel flap gate with single/double rubber bladders, more detailed planning is needed. Moreover, gate owners need to have a good relationship with the authorities in order to carry out this project. The necessary level of riverbed must be negotiated with the authorities. The reason is that the level is determined by technical standard and contracted between the authority and the gate keeper. In conclusion, detailed planning and negotiations are essential. The sample case which the authors have is redesigning now.
