VINGT-QUATRIÈME CONGRÈS  
DES GRANDS BARRAGES  
*Vienne, Juillet 2018*

**SLAKING COUNTERMEASURES RELATED TO ROCK CONTACT  
EXECUTION AT THE SOFT ROCKS FOUNDATION<sup>(\*)</sup>**

*Apporo Dam Construction Office, HOKKAIDO PREFECTURAL GOVERNMENT*

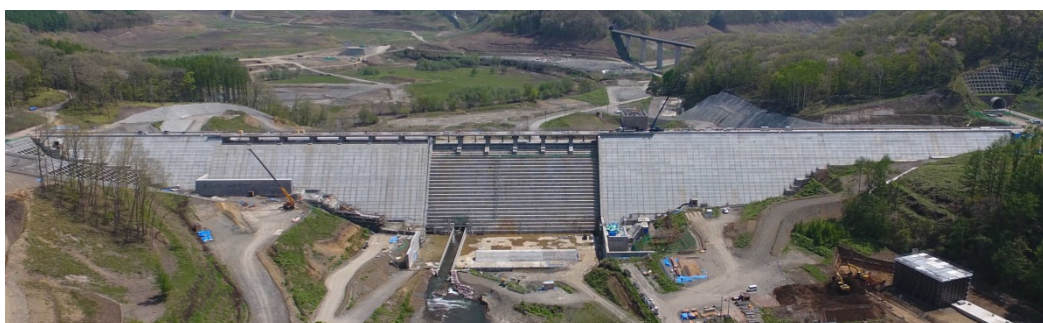
Fig. 1  
Apporo dam under construction  
*Barrage d'Apporo en construction*

Apporo dam is a multi-purpose dam now under construction at the Azuma river in Horonai frontage of Atsuma town, Yufutsu district of Hokkaido prefecture as part of comprehensive development of the Azuma river. The dam is, as shown in Table 1, 47.2 m in height, 47,400,000 m<sup>3</sup> in total reservoir capacity, and 43,100,000 m<sup>3</sup> in effective reservoir capacity. The purpose of dam is to regulate flooding, maintain the normal functions of the river flow, and to supply water to irrigation systems and to urban area. As shown in Fig. 1, the construction of main dam body has been completed and initial impoundment started in October 2017.

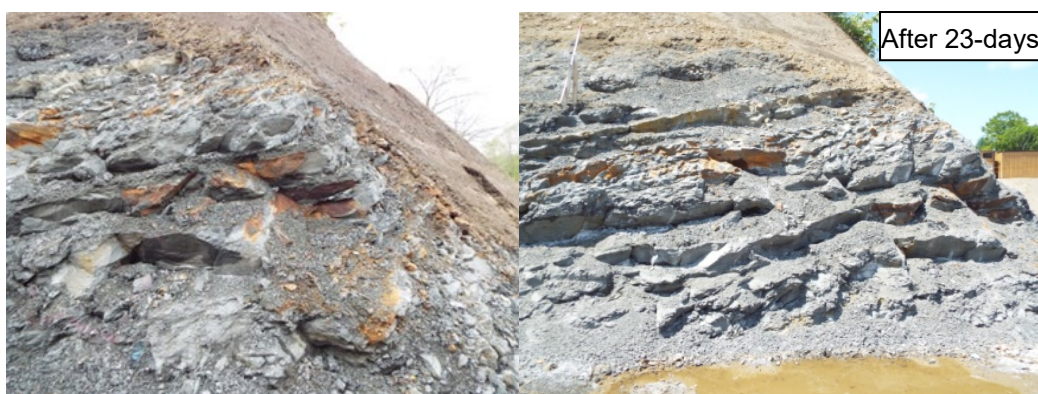
Fig. 4  
 Slaking of shale strata exposed at long period  
*Relâchement de la couche de schiste exposée à longue période*

However, where the surface of bedrock is exposed, hexagonal cracks caused by slaking occur and leads to fine fragments of bedrock (see Fig. 4). So, since the start of the survey, it was understood that this would be a problem to be solved for dam construction. As a result of a past survey, it was known that if bedrock surface was exposed, hexagonal cracks occurred in about 2 days, but they did not become mud, and that when the surfaces were protected by submersion or mortar, hexagonal cracks did not occur.

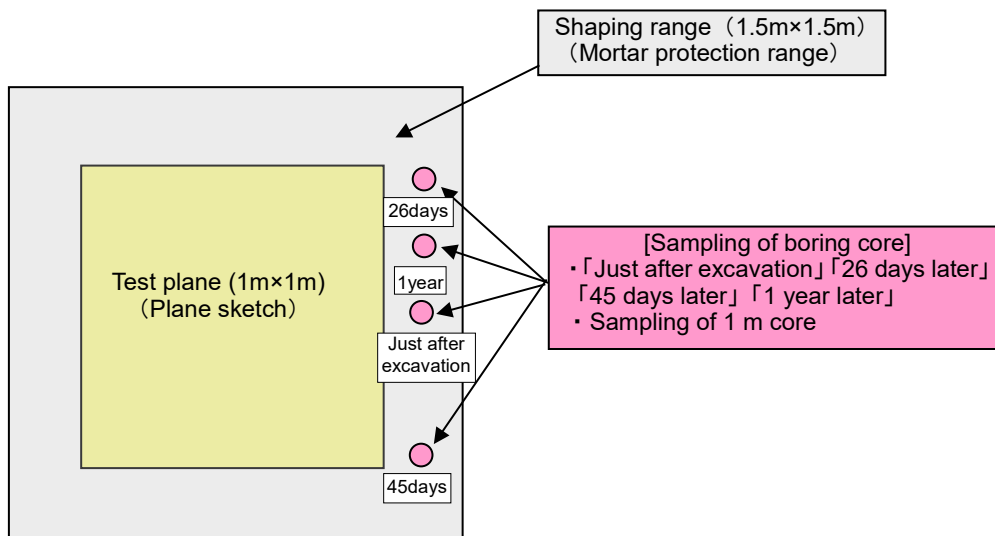
Fig. 7  
 Schematic plan of test surface  
*Plan schématique de la surface de test*

Each test surface was confirmed the state of cracks 3 hours, 6 hours, 1 day, 2 days, 3 days, 7 days, 26 days, 45 days and 1 year after the excavation(see Fig. 6), then the slaking depth was measured by cores sampled 26 days, 45 days and 1 year after the excavation. Locations of cores are shown in Fig. 7.

In the laboratory tests, the core of 1.0 m long sampled just after the excavation in Fig. 7 was repeatedly wetted and dried (10 cycles), confirmed the change of their water absorptions and splintering.

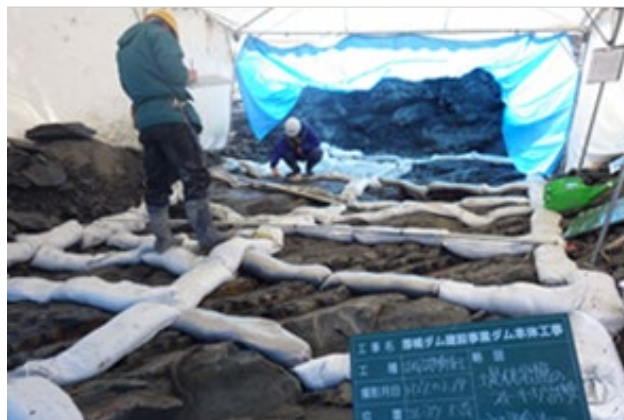
Fig. 12

Slaking confirmation test in field  
*Test de validation de relâchement sur le terrain*

Table 3 shows the curing conditions and verification frequency of the slaking confirmation test. At the test locations, because the confirmation test was reluctantly performed in the winter month of March, the test field was enclosed and heated to adjust weather conditions to match the dam body placing period (see Fig. 12).

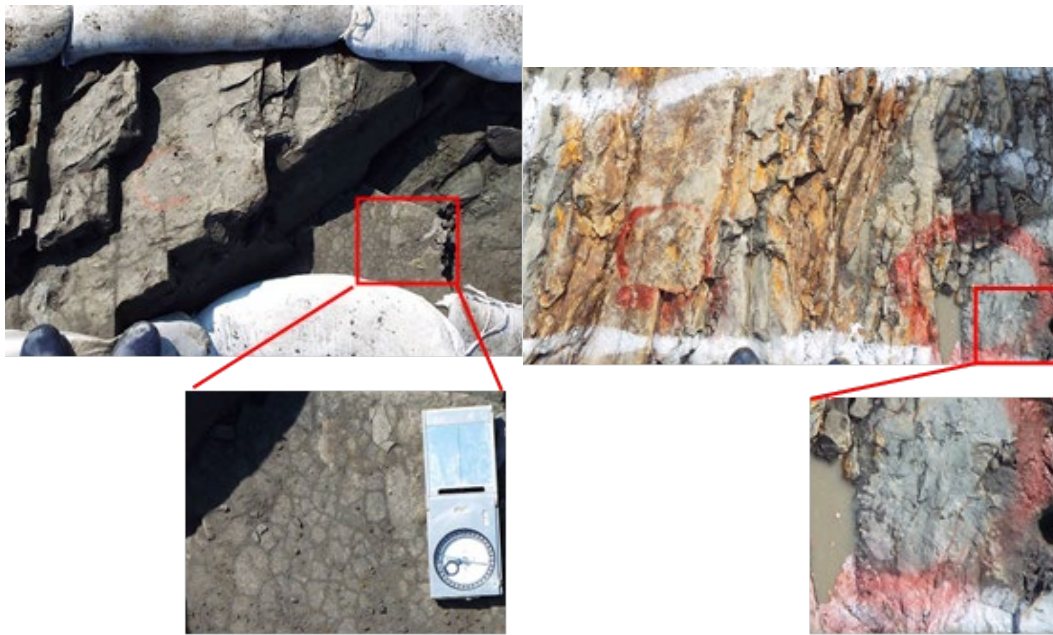
(1) BIIIb grade

(2) BIIIc grade

Crack occurrence at alternation strata of shale and sand stone  
*Apparition de fissure sur l'alternance couche de schiste et de sable*

- On *Shal strata* with BIIIb; when the exposed surface was left uncured, slaking caused hexagonal cracks 2.5 hours later, and drying was accompanied by advance of cracks (see Figs. 13 and 14 (1) ).
- On *Shal strata* with BIIIc; when the exposed surface was left uncured, slaking caused hexagonal cracks 1 hour and 40 minutes later, and drying was accompanied by advance of cracks (see Fig. 14 (2) ).
- On *Sh strata* with BIIIc; when the exposed surface was left uncured, slaking caused hexagonal cracking 1 hour after the start of drying, but this depended on the weather.

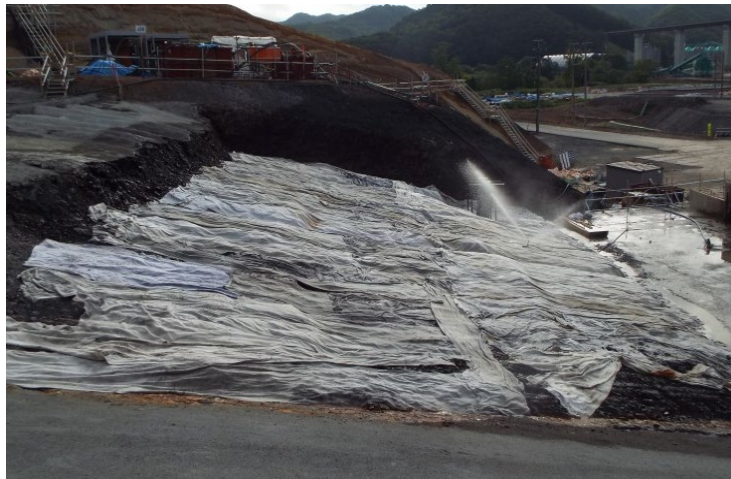
Fig. 15  
Moisture mat curing of dam foundation  
*Maturation par l'humidité de la fondation du barrage*

For this reason, secondary (finishing) excavation exposes the bedrock with classification BIIIb. Then after excavation, moisture mat curing starts within 1 hour, and the mortar is laid and placing starts within 6 days (see Fig. 15).
